HGT BELLHOUSING
INSTALLATION GUIDELINES
VERNIERBELL™

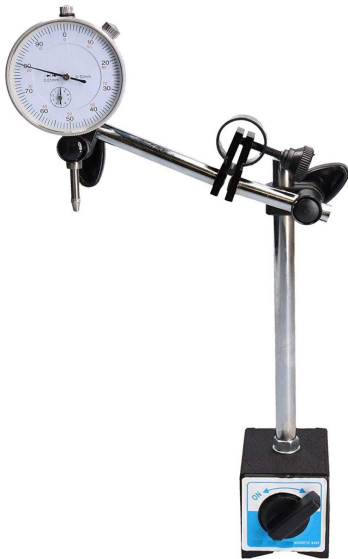
The procedure for checking the alignment of the bellhousing starts out essentially the same way as the conventional process. I.e. by using a magnetic base style dial test indicator, a "DTI", similar to that enclosed in the picture below, this being attached to the crankshaft/flywheel and rotating it $\frac{1}{4}$ or $\frac{1}{2}$ turn at a time. It is usually easier to have the flywheel attached in place to give a good flat metal base for the magnet to secure against. It is not necessary to have all the flywheel bolts attached for this procedure, just three will do, but do make sure the flywheel is sufficiently secure so that it does not move around during rotation of the engine.

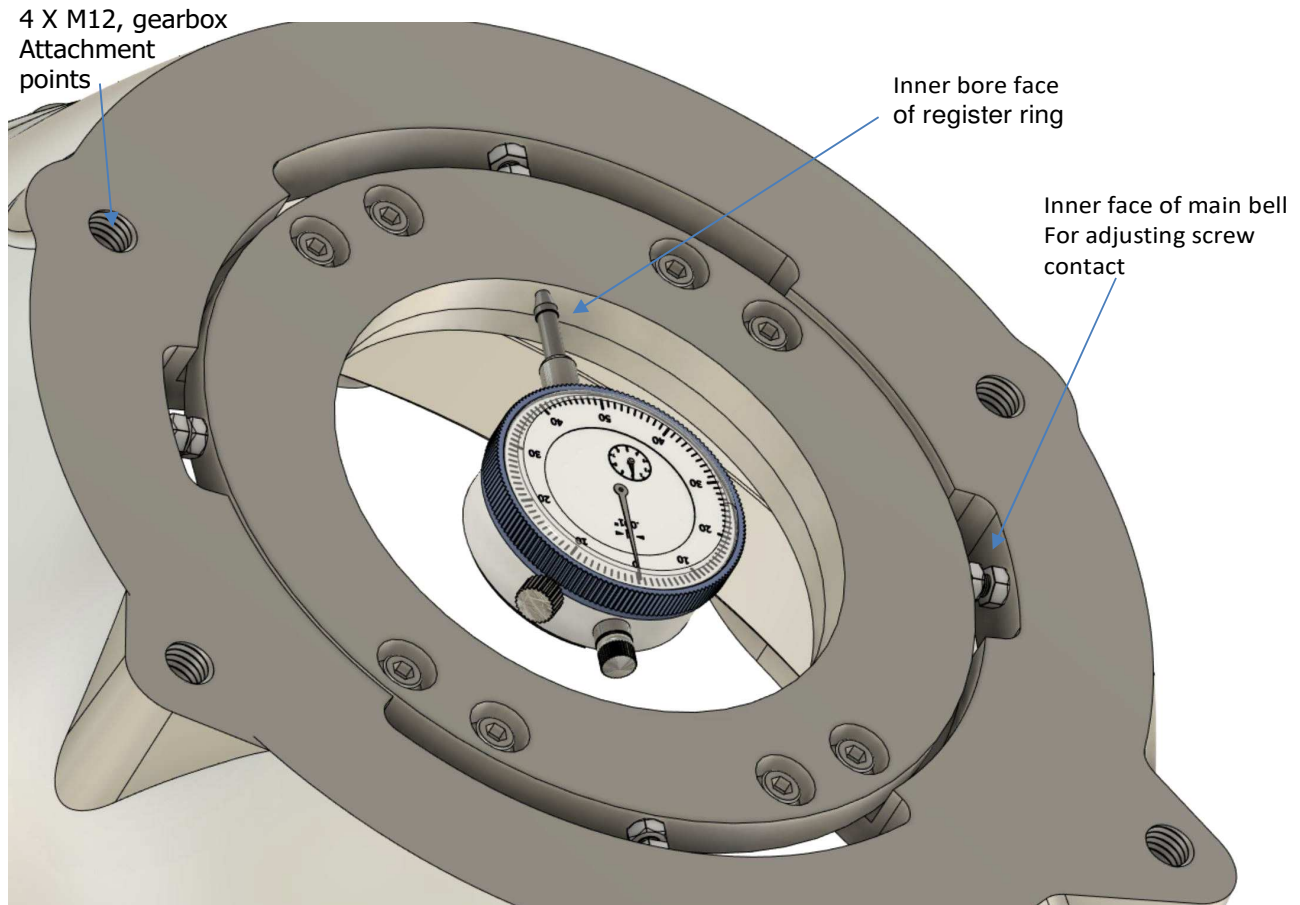
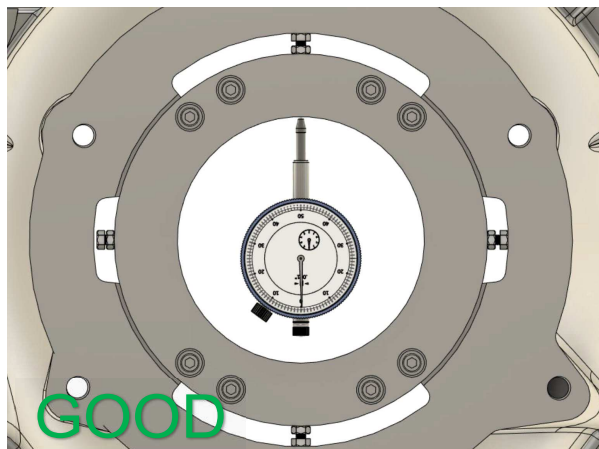
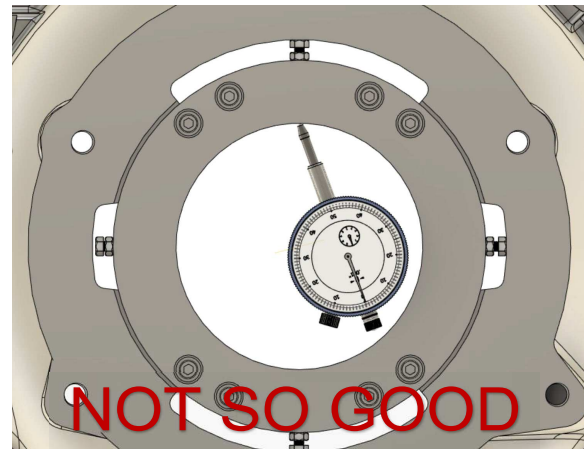
Attach the magnetic base of the DTI to the crankshaft/flywheel, use the multi part adjustable support arm of the DTI to obtain the best tip contact position, this make take a little time and patience for those unfamiliar. Placement of the DTI should be as radial as possible, avoid tangential angle if possible. Ensure the tip of the DTI is against the inner bore of the register ring. (Not the main bore of the bellhousing)

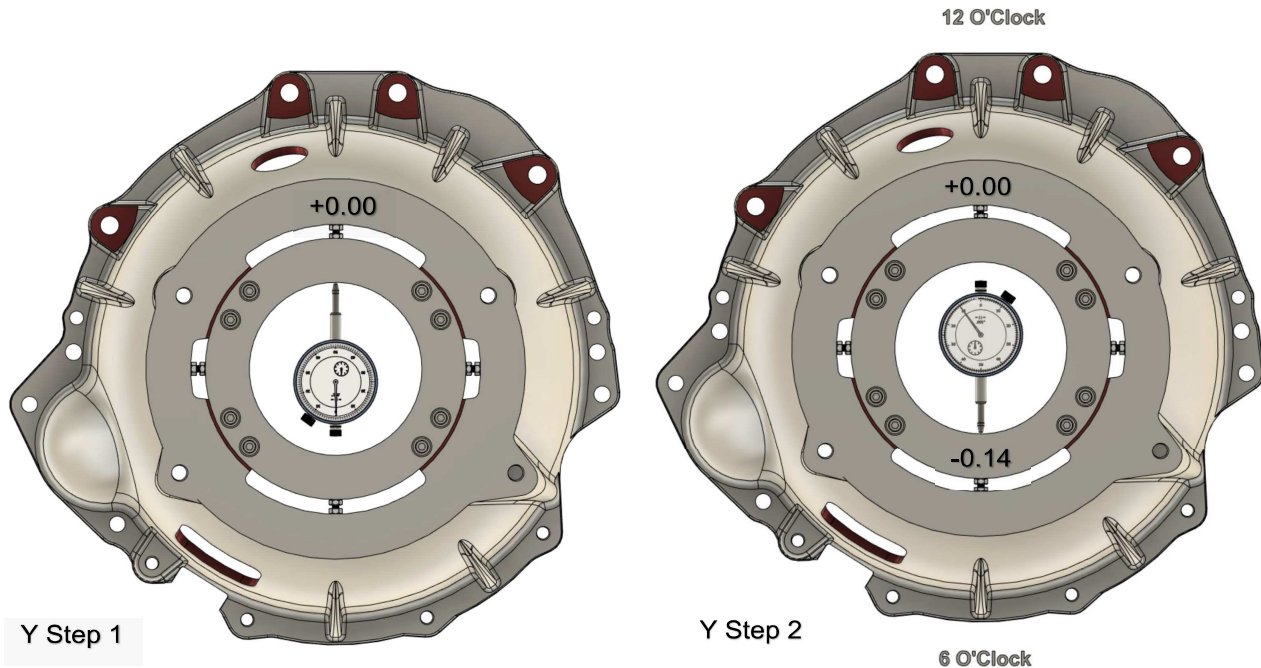
Rotate the crankshaft of the engine so that the DTI is pointing to 12 O'clock position.

Zero the DTI at this step as the starting point for readings

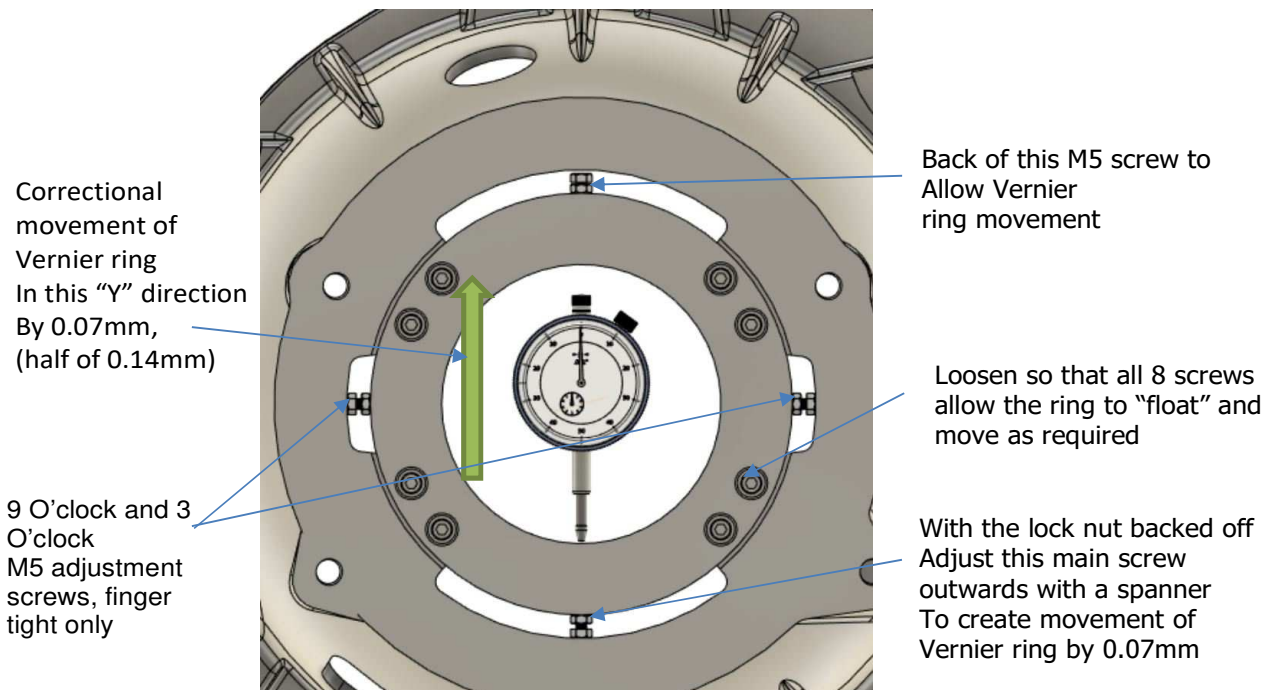
As in the diagram above, back off the otherwise finger tight 12 O'clock position M5 adjustment screw, because the Vernier ring needs to move in this direction by 0.07mm

Loosen off those two otherwise slightly tight M6 clamping screws so that the Vernier adjusting ring is now free to move.

Now carefully adjust the opposite, i.e., the 6 O'clock adjustment screw with a small open ended spanner, rotating it anticlockwise. This will cause the screw to move out of its threaded hole reacting on the bellhousing body inner face causing the Vernier adjusting ring to move towards 12 O'clock. Some judgment will be required to know how much rotation of the small screw is needed to achieve the amount required, however it is possible with practice to actually see the movement occur if the DTI is located in the 12 O'clock or 6 O'clock position.

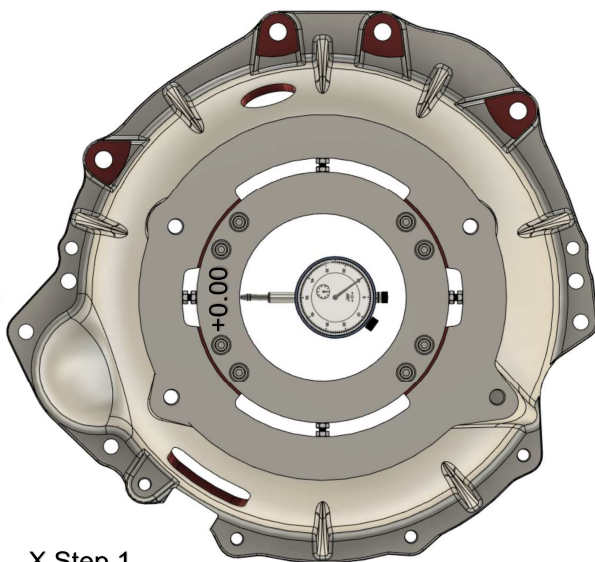
X Step 1

Rotate the crankshaft of the engine so that the DTI is pointing to 9 O'clock position.

Zero the DTI at this step as the starting point for readings

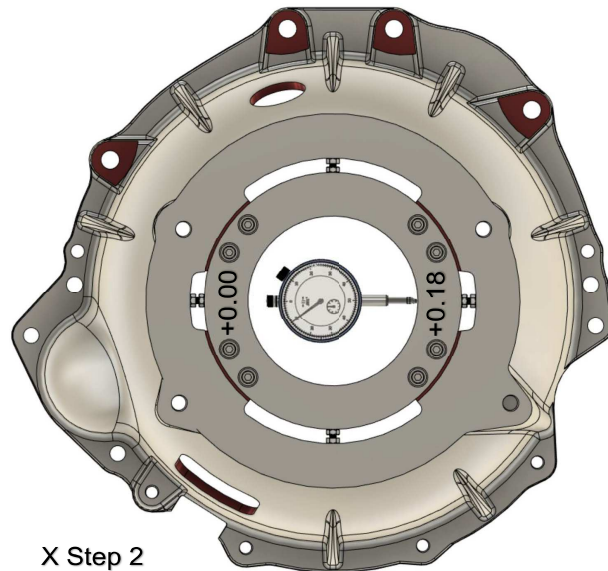
X Step 2

Rotate the crankshaft of the engine again by 180 degrees so that the DTI is pointing to 3 O'clock position.

Now make a note of the displacement on the DTI at this 3 O'clock position.

We will make an assumption in this example that it is + 0.18 mm at the 3 O'clock position.

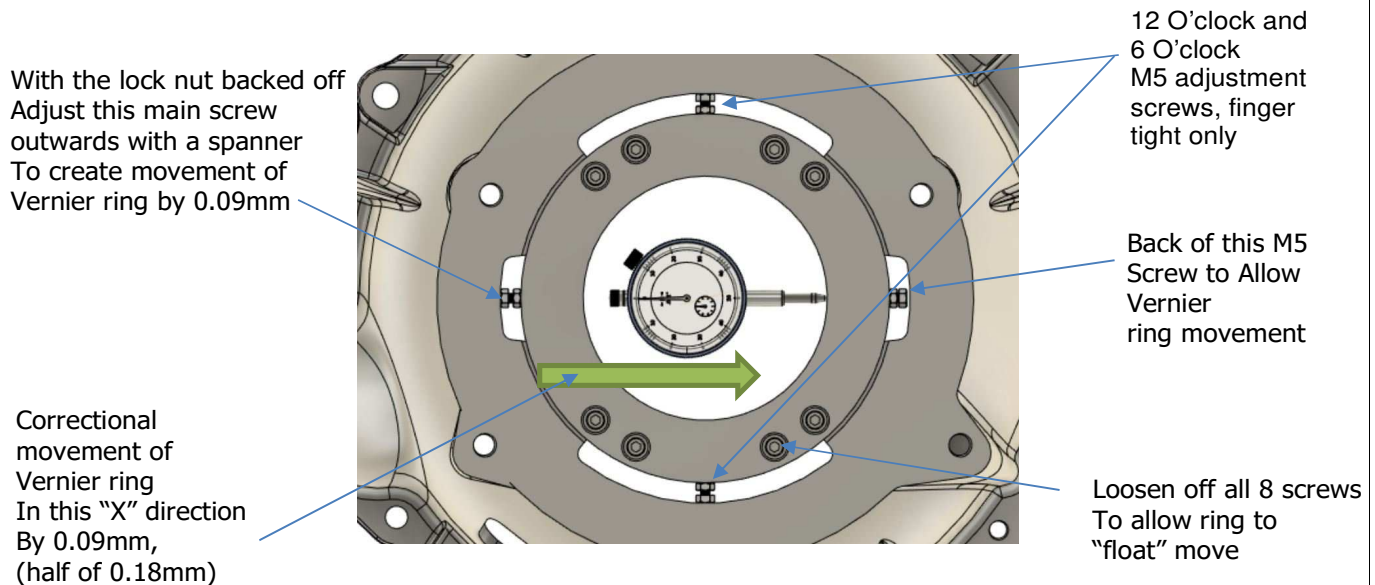
As in the diagram above, back off the otherwise finger tight 3 O'clock position M5 adjustment screw, thread it into the ring to leave a small gap, because the Vernier ring needs to move in this direction by 0.09mm

Loosen off those two otherwise slightly tight M6 clamping screws so that the Vernier adjusting ring is now free to move or float.

Now carefully adjust the opposite screw, i.e. the 9 O'clock adjustment screw, with a small open ended spanner, rotating it anticlockwise. This will cause the screw to move out of its threaded hole reacting on the bellhousing inner face causing the Vernier adjusting ring to move towards 3 O'clock. Some judgment will be required to know how much rotation of the small screw is needed to achieve the movement required.

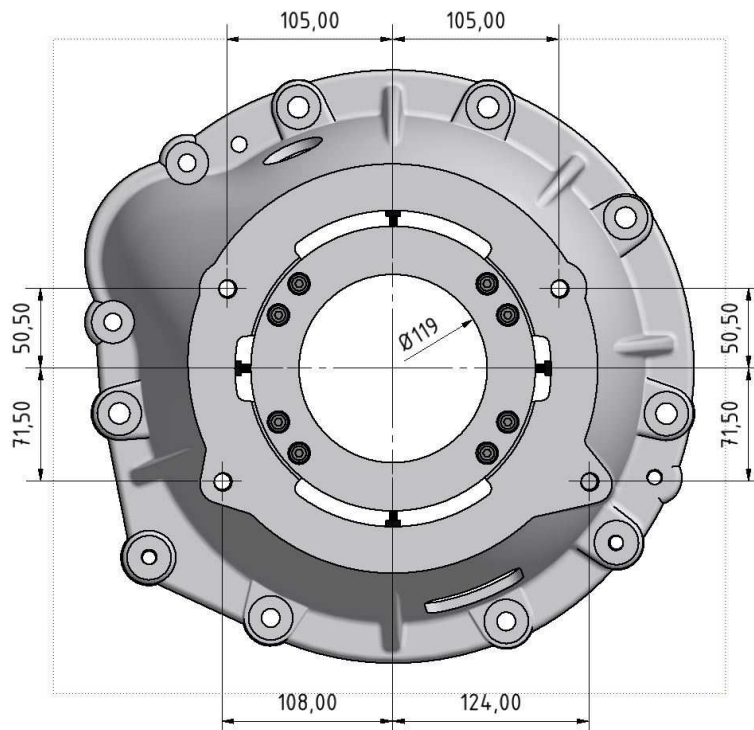
Gearbox mounting holes pattern with 119 mm diameter bore register, dimensions shown are in millimetres:
